**REPORT – 1****REVIEW OF BANJAR PANJI-1 INCIDENT  
PLANNING AND EXECUTION OF DRILLING PROGRAM****1.0 SUMMARY:**

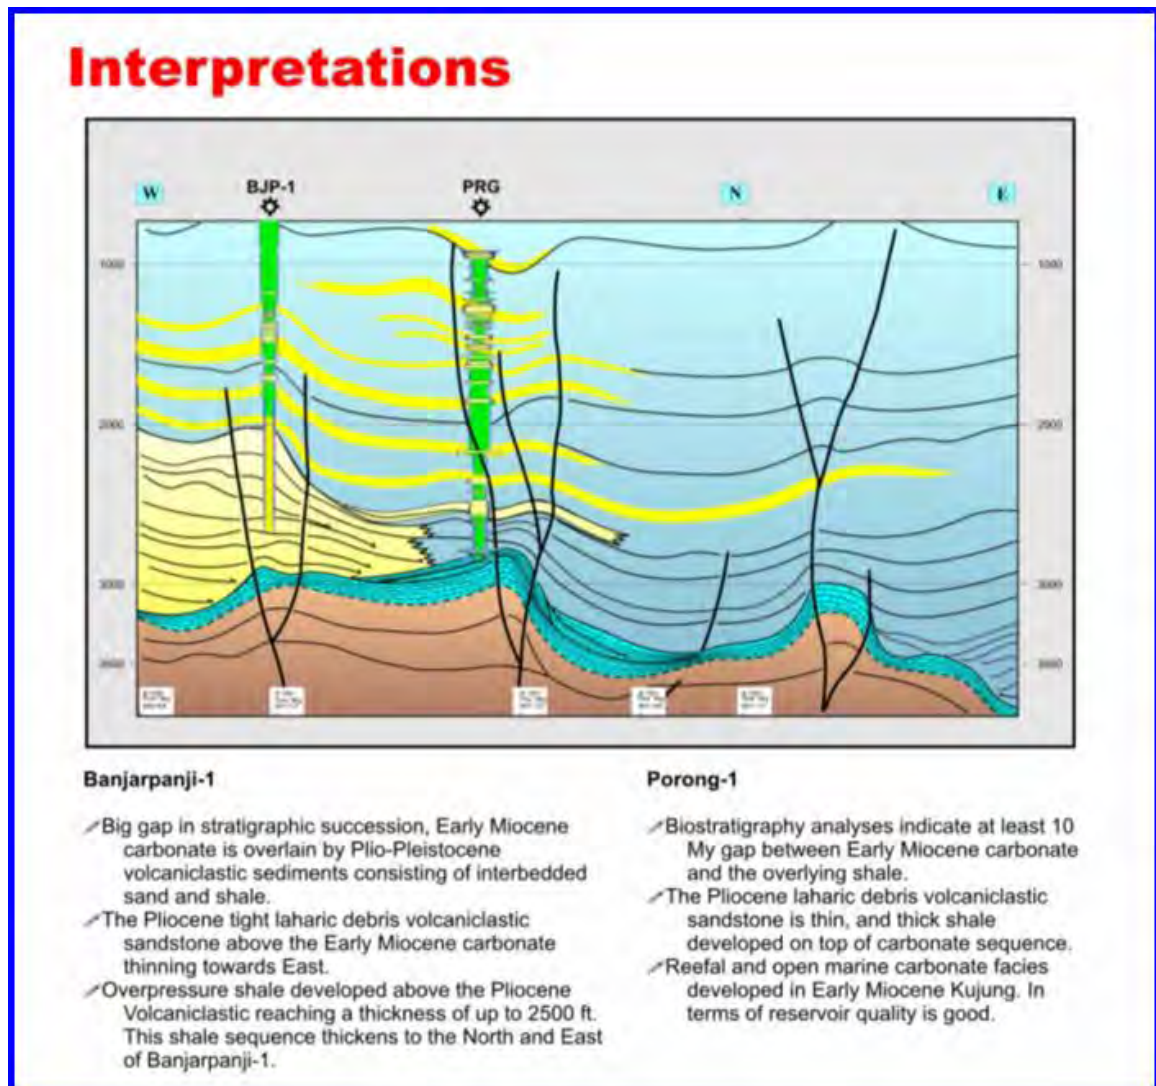
There was, however, a major difference between the BP-1 and Porong-1 wells: BP-1 well encountered an unexpected sand package below the shale prior to entering the target Kujung Formation, shown in Figure 2. The sand package is thick – 2,800' (approximately from 6300' to 9100') – and turned out to be hard volcanic sandstone. It appears similar in nature to turbidites, and may represent lahar material that came loose from the volcanic mountains in the vicinities and flowed into the depositional area as a liquefied mass. This would turn out to be an important difference as sandstones do not make good caprock (sealing rocks), and tend to act as bleed-off zones for elevated pressures. In contrast, shales are considered to be the source of pressure buildup because of compaction and constrained expulsion of water. They are highly impermeable if they are intact (unfractured), and thus tend to make good caprock.

Figure 2 Geological setting comparisons between Banjar Panji -1 & Porong -1 wells

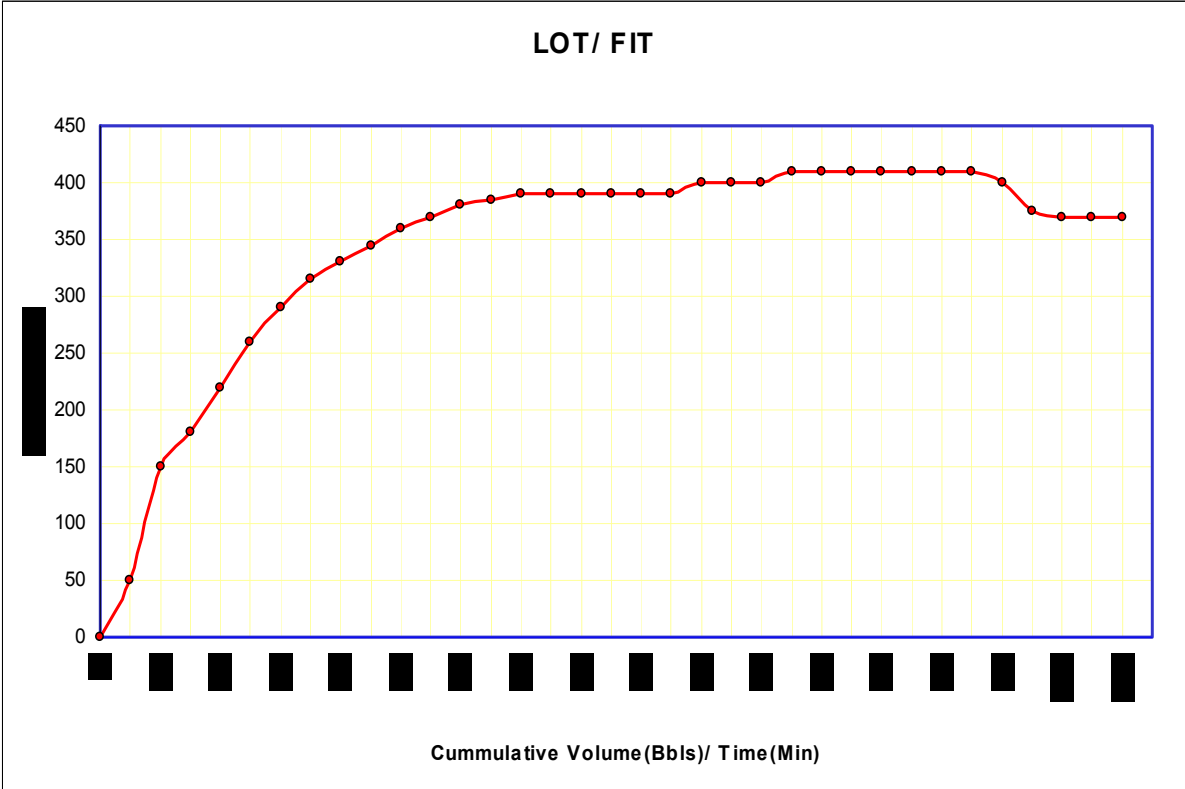
Figure 7: Actual leakoff test data at 13 3/8" casing shoe in Banjar Panji-1 well

In the BP-1 well, the LOT value at the 13 3/8" casing shoe was a robust 16.4 ppg, which exceeded expectations. In fact, the shoe test at 13 3/8" was slightly higher than what was expected for the 11 3/4" casing shoe in the original drilling plan.

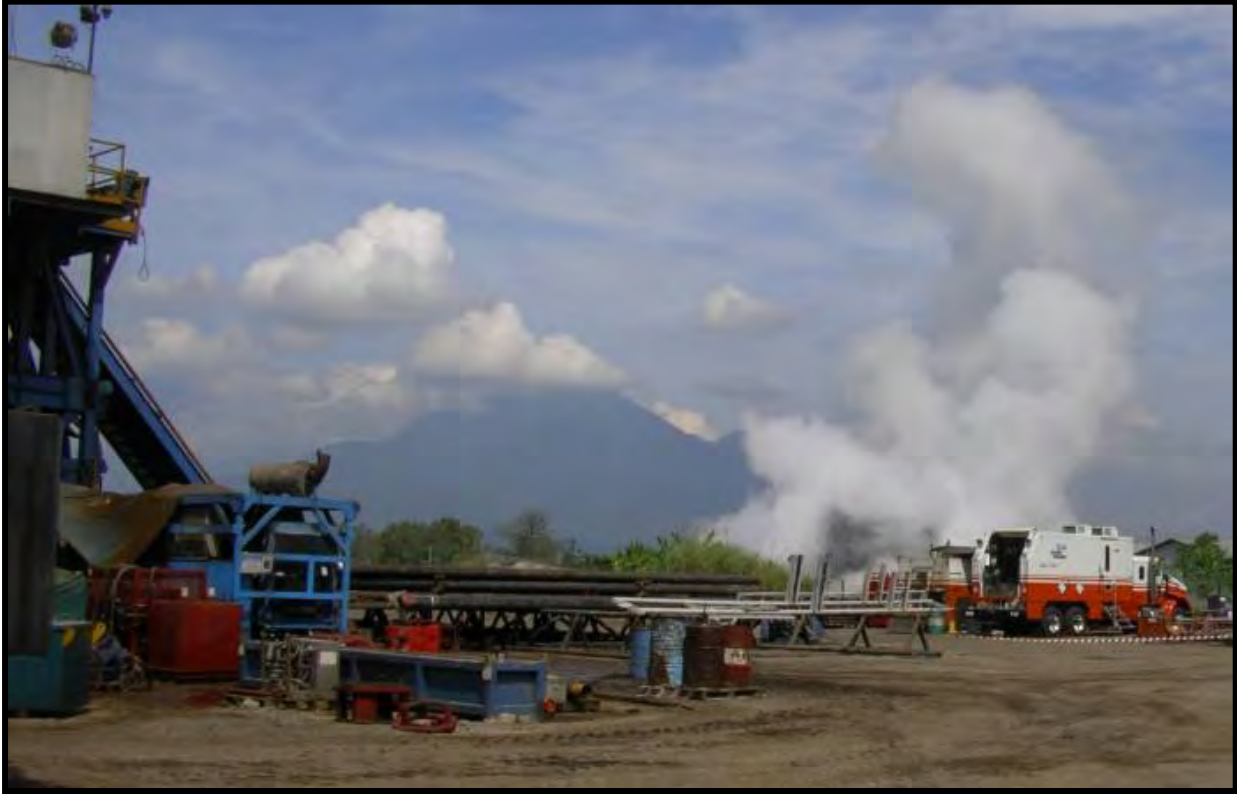
Once the well was dead, an attempt was made to resume the pull-out procedure; however, the pipe was stuck. The rig crew worked the pipe with a maximum pull of 400,000 lbs, but without success. Several other procedures including jarring and spotting a high-viscosity drilling fluid pill were tried for 20 hours, but without success. Then, gas and water (plus steam) – a fumarole – broke out at the surface 200 meters away from the borehole at 03:30 hrs on May 29<sup>th</sup>, 2006 (Figure 8).

Figure 8: Surface breach & fumarole 200 meters away from the rig on May 29<sup>th</sup>, 2006

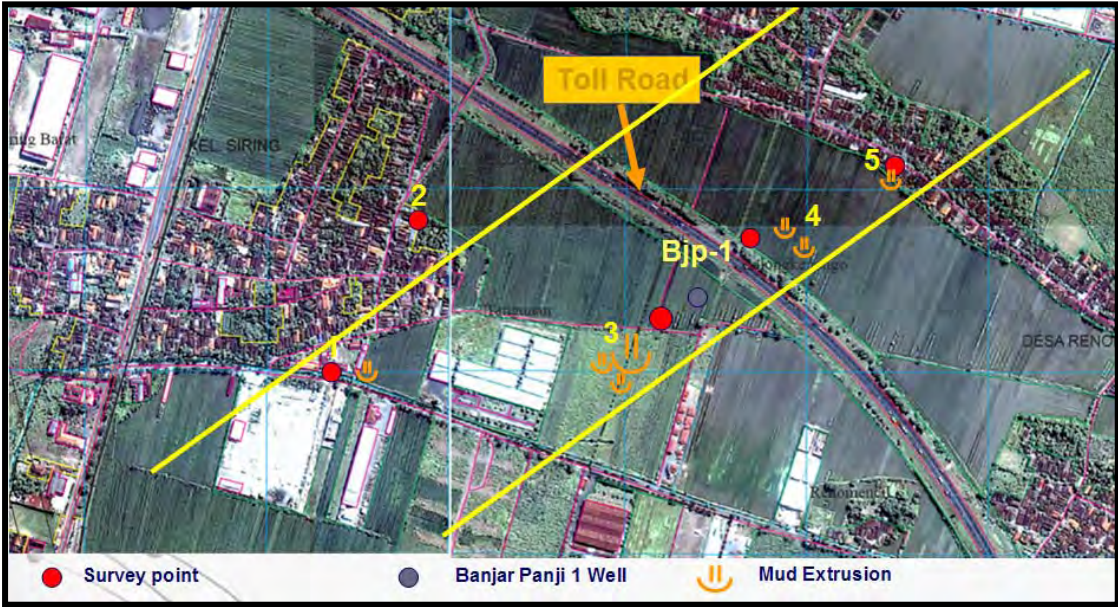
Attempts were made to pump weighted mud through the drill pipe to control the flow out of the fumarole, but no connectivity was observed with the well, which was dead (neither flowing nor experiencing lost circulation). The flow from the fumarole continued to increase with two other fumaroles popping-up across the toll road, some 500 meters away from the drill site (Figure 9). In spite of trying to pump heavy mud in the wellbore, no fluid connectivity (i.e. pressure response or fluctuation, inflow or efflux) was observed between the wellbore and the fumaroles. Several attempts were made to pump LCM and cement to control the mud flow rate in the fumaroles but with no success. For some reason, the borehole had become totally disconnected from the induced fracture system that was bringing liquids, gas and mud to the surface as fumaroles.

Figure 9: Two more fumaroles initiating parallel to a fault line, including the relative location of the well

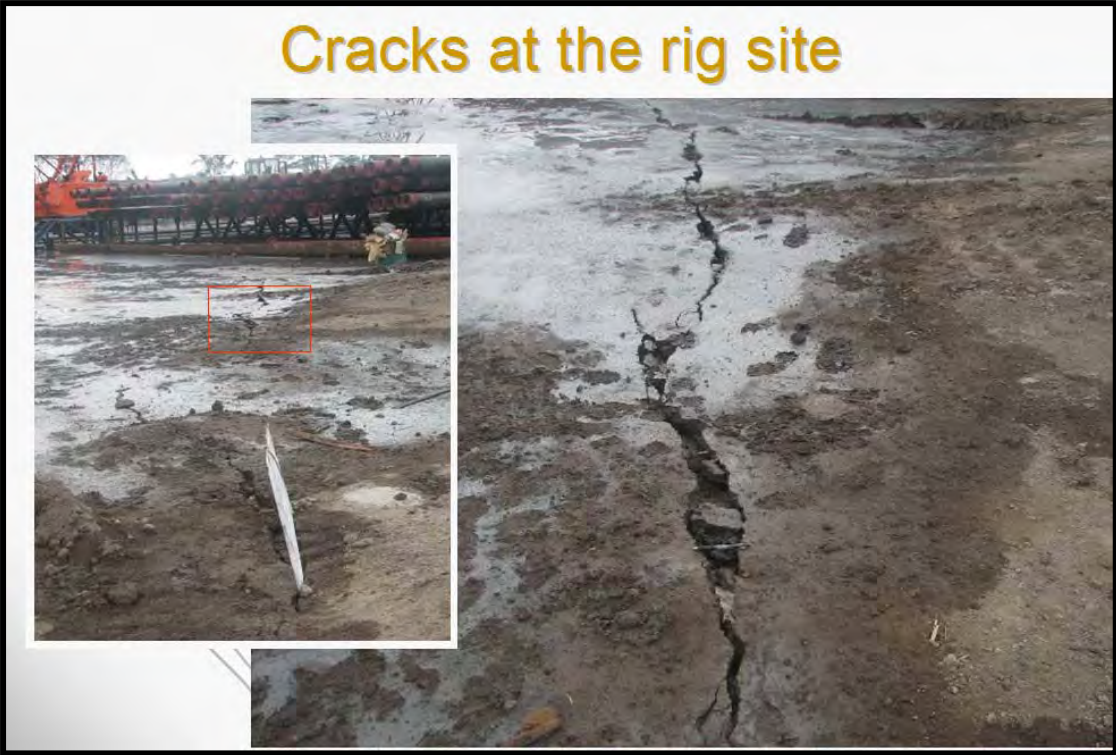
With the flow rates from the fumaroles continuing to increase, the danger of flooding the area surrounding the rig began to increase. A ground crack also was noted around the rig site under the pipe-rack (Figure 10).

Figure 10  
A crack develops near the pipe-rack in the vicinity of the rig

With the ground crack under the pipe-rack and mud starting to flow over the berm wall into the drill site, a decision had to be made in the field either to stay on site or to abandon the well and demobilize the rig. The decision was made to abandon and demobilize the rig because of safety reasons. Staying on the well at that time would have served no useful purpose, and would have exposed men and materials unnecessarily to an unknown and dangerous situation. Proper management authorization was secured in finalizing the rig-down command.
