**REPORT – 1****REVIEW OF BANJAR PANJI-1 INCIDENT  
PLANNING AND EXECUTION OF DRILLING PROGRAM****1.0 SUMMARY:**

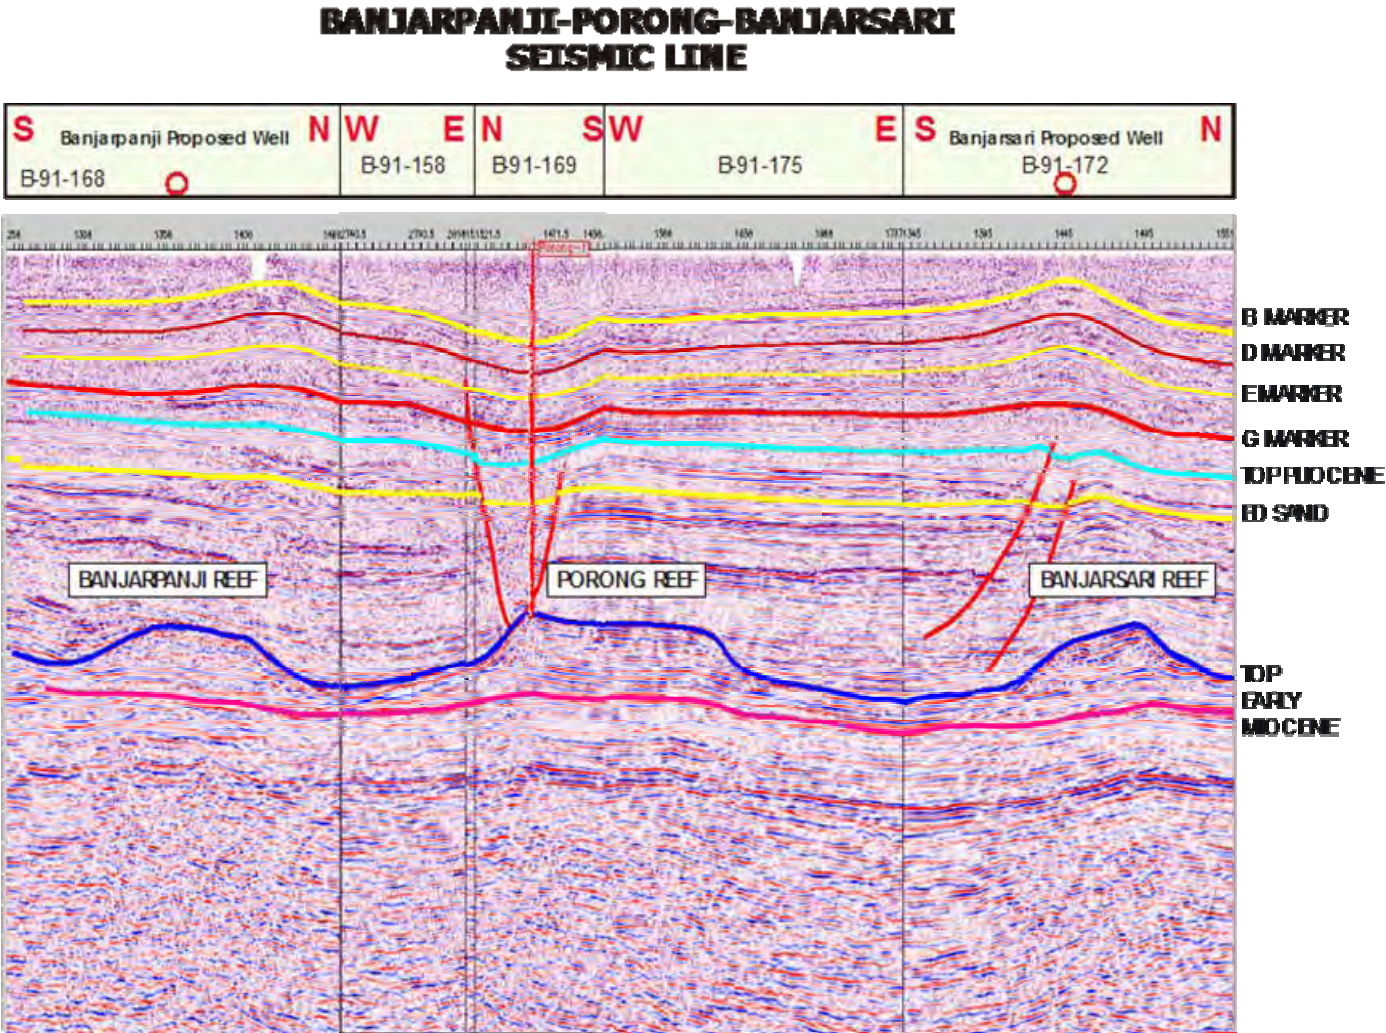
Figure 1 Geophysical Description of the Trend

The lithostratigraphic sequence and general geological setting was expected to be similar to that encountered in the Porong-1 well. A geophysical (seismic) cross-section comparing the two wells is shown in Figure 1. Note that the BP-1 well is in a more defined structure as compared to Porong-1 well. It appears that Porong-1 well was drilled close to the remnants of a fluid migration chimney. Such geological settings are prone to borehole instabilities and more variation in rock properties and *in situ* stresses. A better defined structure, such as in BP-1, would in general indicate fewer borehole stability issues and better well control characteristics.

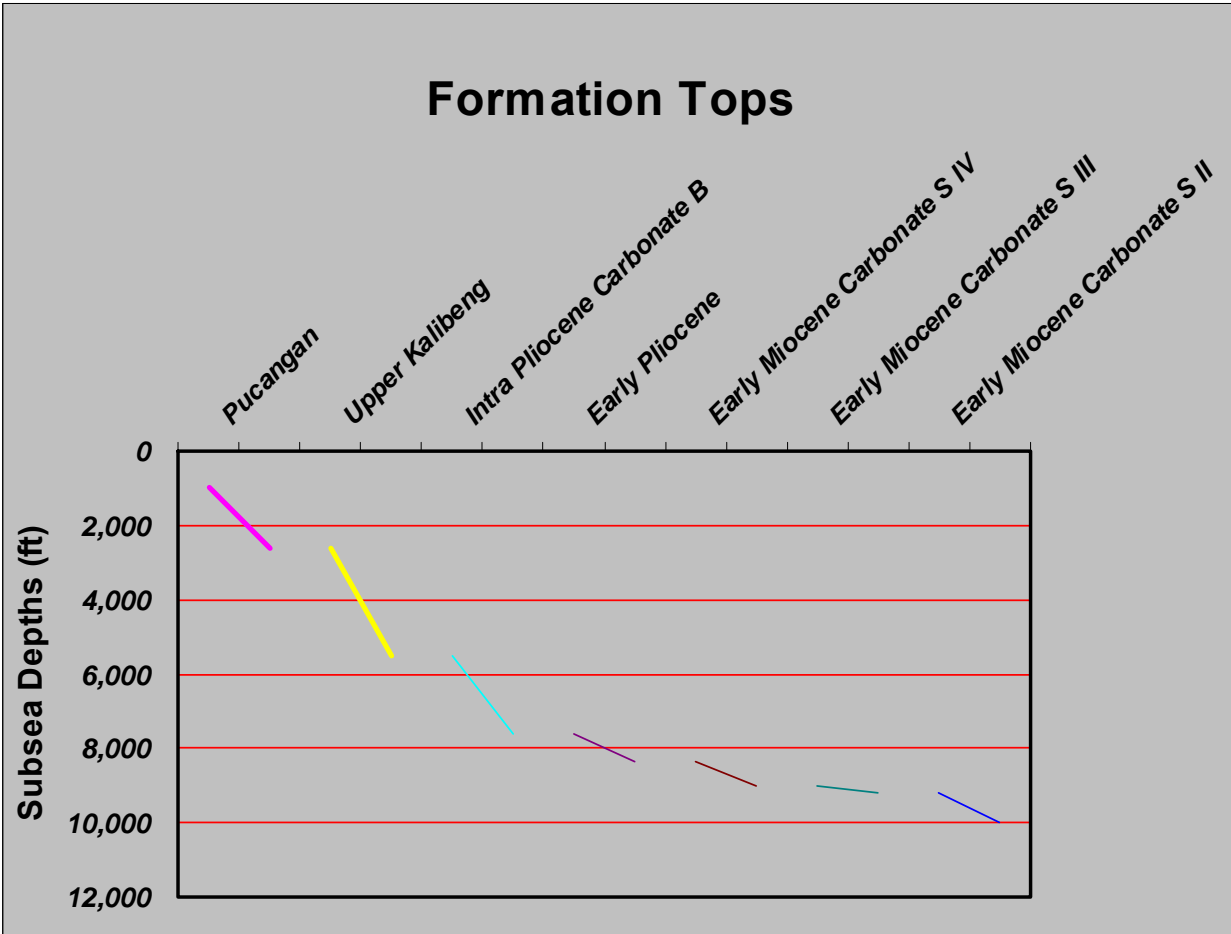
Figure 3 Geological description of lithology expected in Banjar Panji -1 well

Pressure estimates with depth for the BP-1 well were made based on data from the offset wells combined with geophysical log information. Figure 3 shows the geological sequence that was expected to be penetrated during the drilling of the BP-1 well.

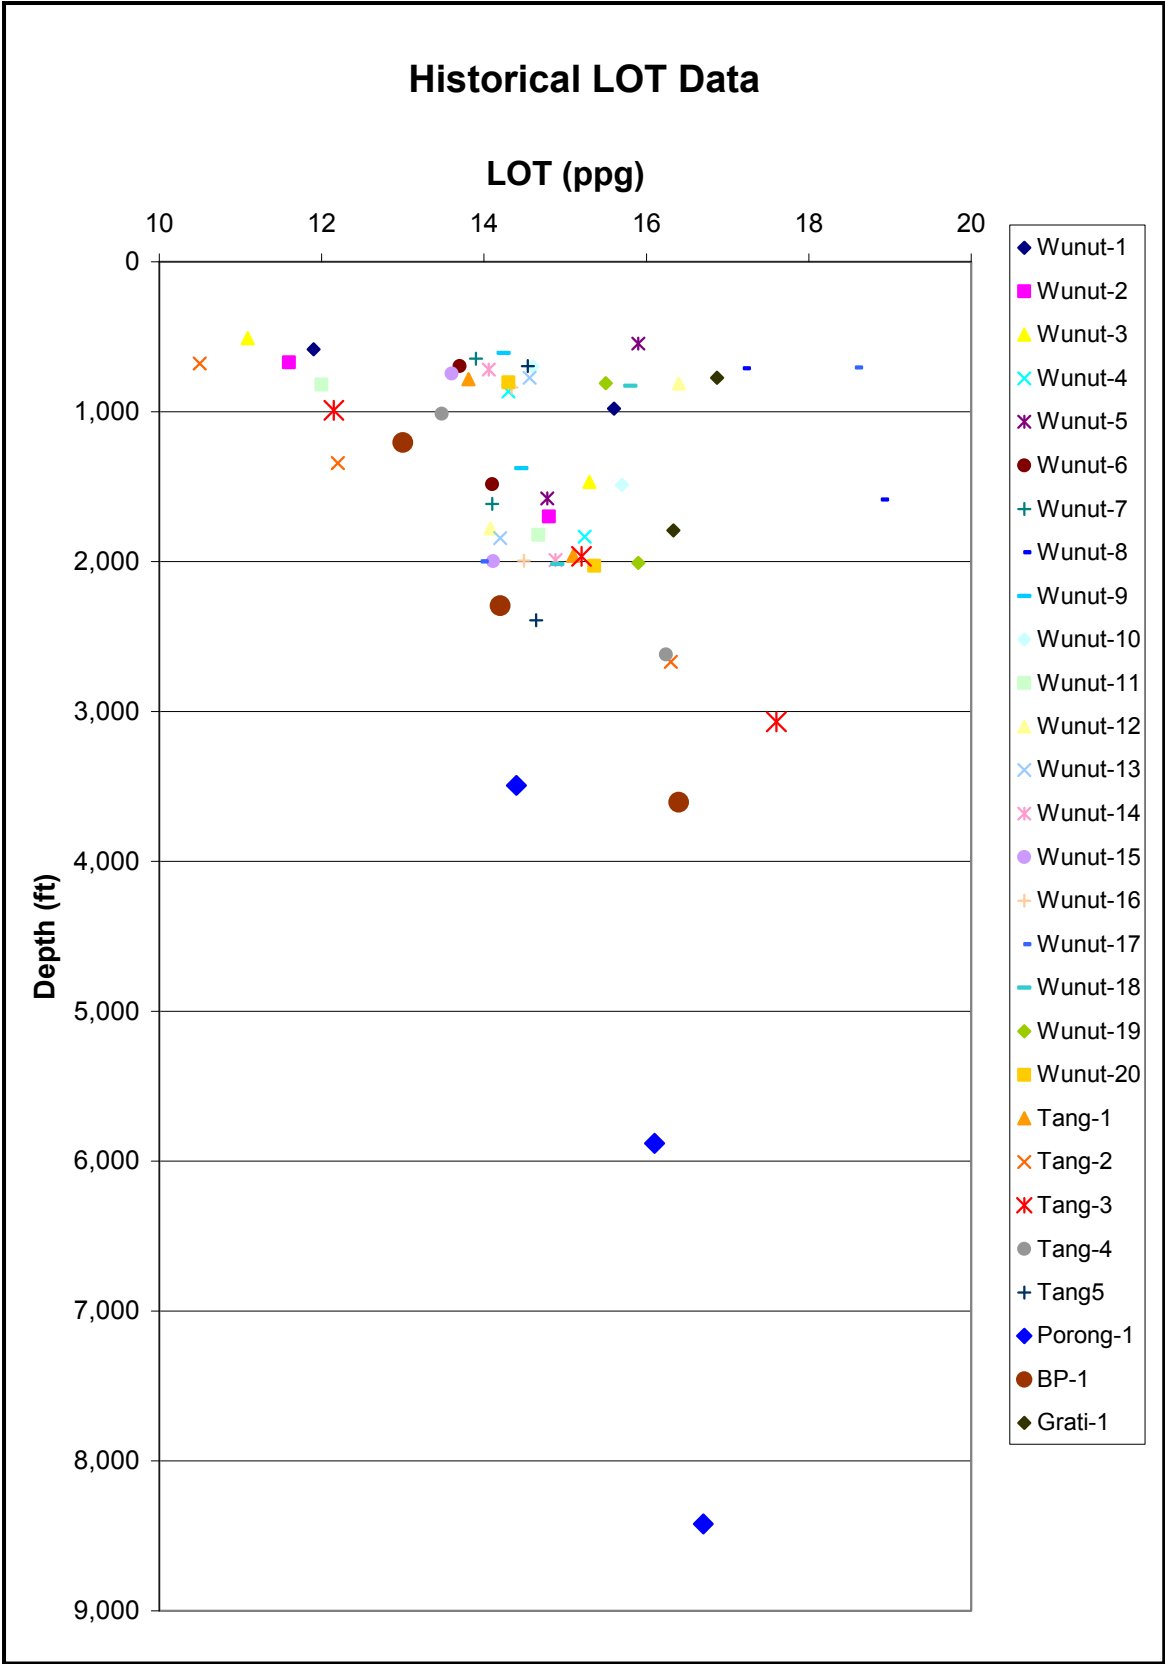
Figure 4: Compilation of historical data on leak-off tests from the region

LOT data was compiled for all the wells; the data available are shown in Figure 4. Both pore pressure and LOT information are considered to be critical in well design and selecting casing points in planning to avoid both blowout conditions and lost circulation through formation fracturing.

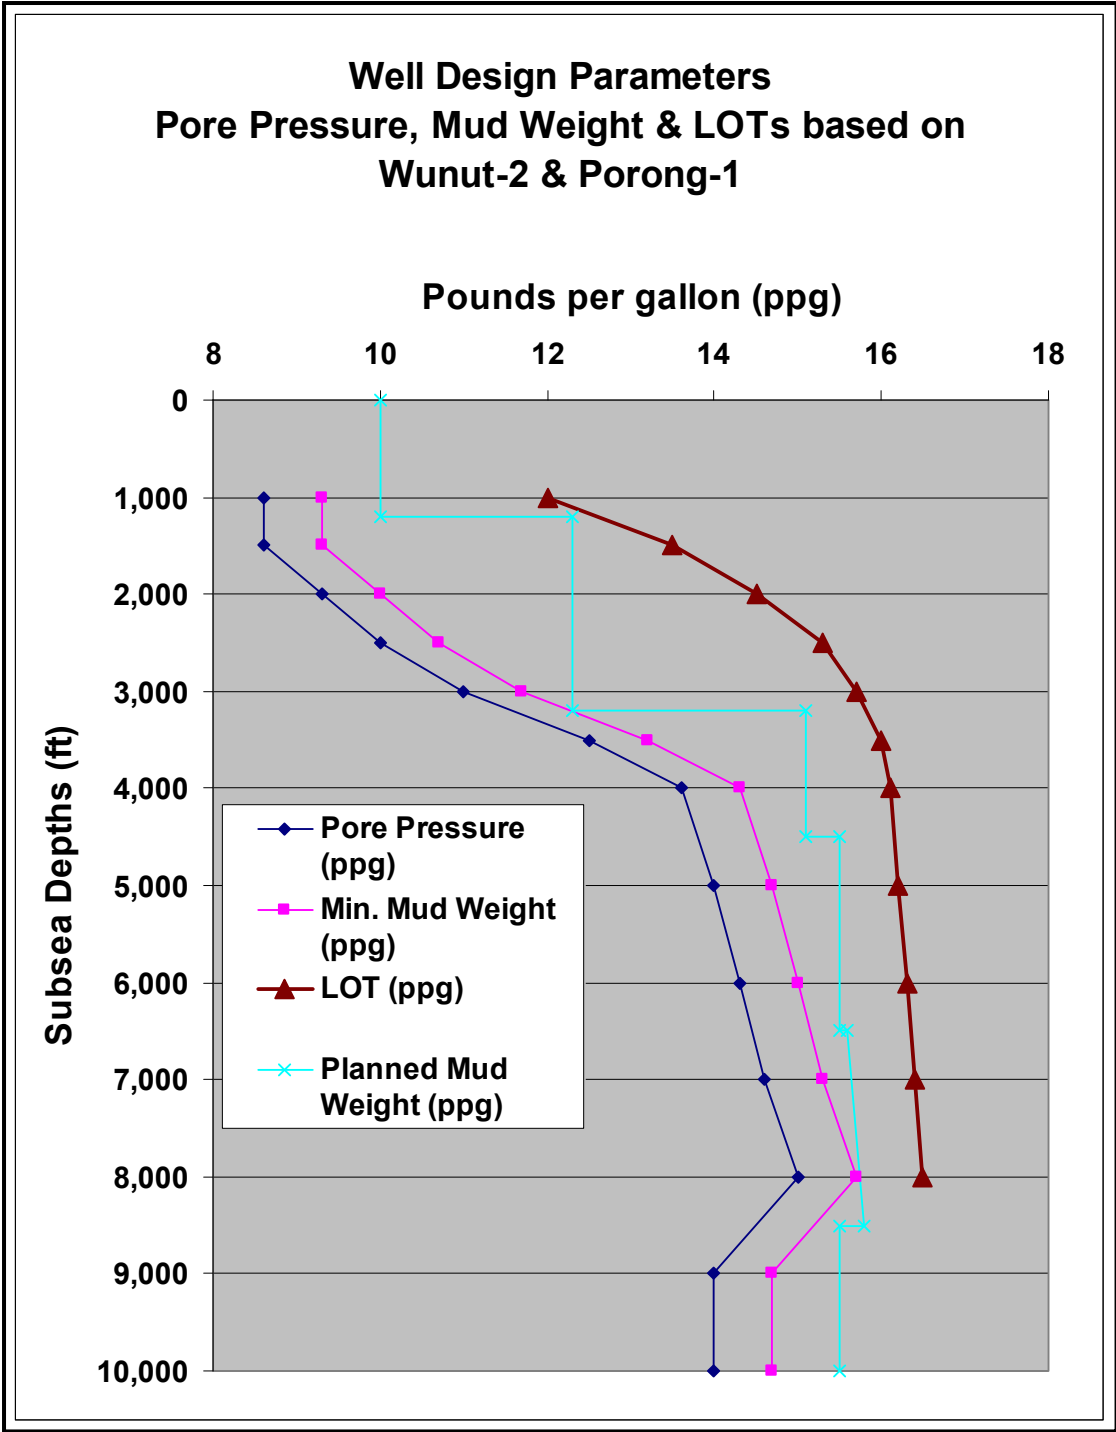
Figure 5

The shallow section of the BP-1 well was designed based on the Wunut 2 offset well, the closest producing well, less than 2 km away. The deeper sections were based on several wells, including the failed well designs for BD-1, KE-11C, KE-11G and Porong-1, as well as the successful well designs for KE-11E and BD-2. A key lesson learned from the Porong-1 well was the existence of pressure regression of about 1 ppg in the fractured limestone that makes up the Kujung Formation. Hence, a decision was made to set the 9 5/8" casing after entering 15 to 20' into the Kujung carbonate, thus isolating the abnormally pressured shales that were expected above the top of the Kujung Formation. However, because of the presence of natural fractures in the carbonate, it was also expected that it might be necessary to set a contingency casing string with a diameter of 7" if a zone of severe lost circulation was encountered below the base of the 9 5/8" casing. This is a common approach, and it emphasizes the need to retain as large a hole diameter as is reasonable when entering the carbonate strata, in order to isolate any unexpectedly severe lost circulation zones. Figures 5 & 6 show the planned well design parameters and the wellbore schematic.
